Common Pacemaker Problems: Lead and Pocket Complications

Enes Elvin Gul and Mehmet Kayrak
*Selcuk University,
 Meram School of Medicine,
 Cardiology Department Konya,
 Turkey*

Modern Pacemakers - Present and Future

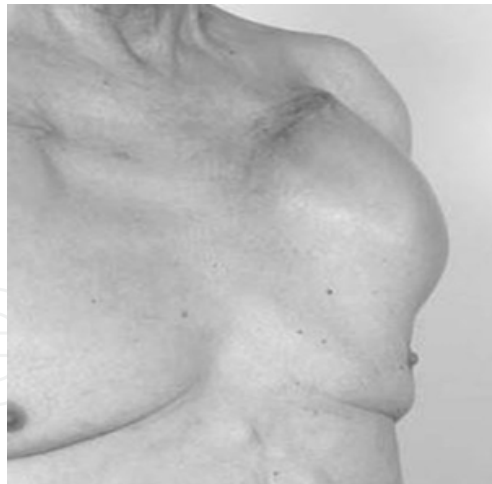
Fig. 8. Pocket hematoma

Hematomas occurring at the pacemaker pocket site can vary from a small ecchymosis to large and tense swelling (Figure 8). The risk of haematoma is increased in patients taking antithrombotic or anticoagulant drugs (Goldstein et al., 1998). Most small hematomas can be managed conservatively with cold compress and withdrawal of antiplatelet or antithrombotic agents. In patients requiring oral anticoagulants (warfarin), to take INR of about 2.0 at the time of implantation is safe (Belott & Reynolds, 2000). Unfractionated heparin or low-molecular-weight heparin are always discontinued prior to device implant and ideally avoided for a minimum of 24 hours post implantation. Administration of anticoagulants can be resumed within 48-72 h after implantation if there is no evidence of substantial hematoma formation. Occasionally, large hematomas that compromise the suture line or skin integrity may have to be surgically evacuated. Evacuation of the hematoma is very rarely needed (<0.5% of cases). Needle aspiration increases risk of infection and should not be done. Aspiration should be considered only if there is continued bleeding, potential compromise of the suture line or skin integrity, or pain refractory analgesics (Pavia & Wilkoff, 2001).
